REUBEN HART RESERVOIR DAM

CT 00096

PHASE I INSPECTION REPORT
NATIONAL DAM INSPECTION PROGRAM

Identification No.: CT 00096
Name of Dam: Reuben Hart Reservoir Dam
City: Torrington
County and State: Litchfield, Connecticut
Stream: Hart Brook
Date of Inspection: 24 October 1978

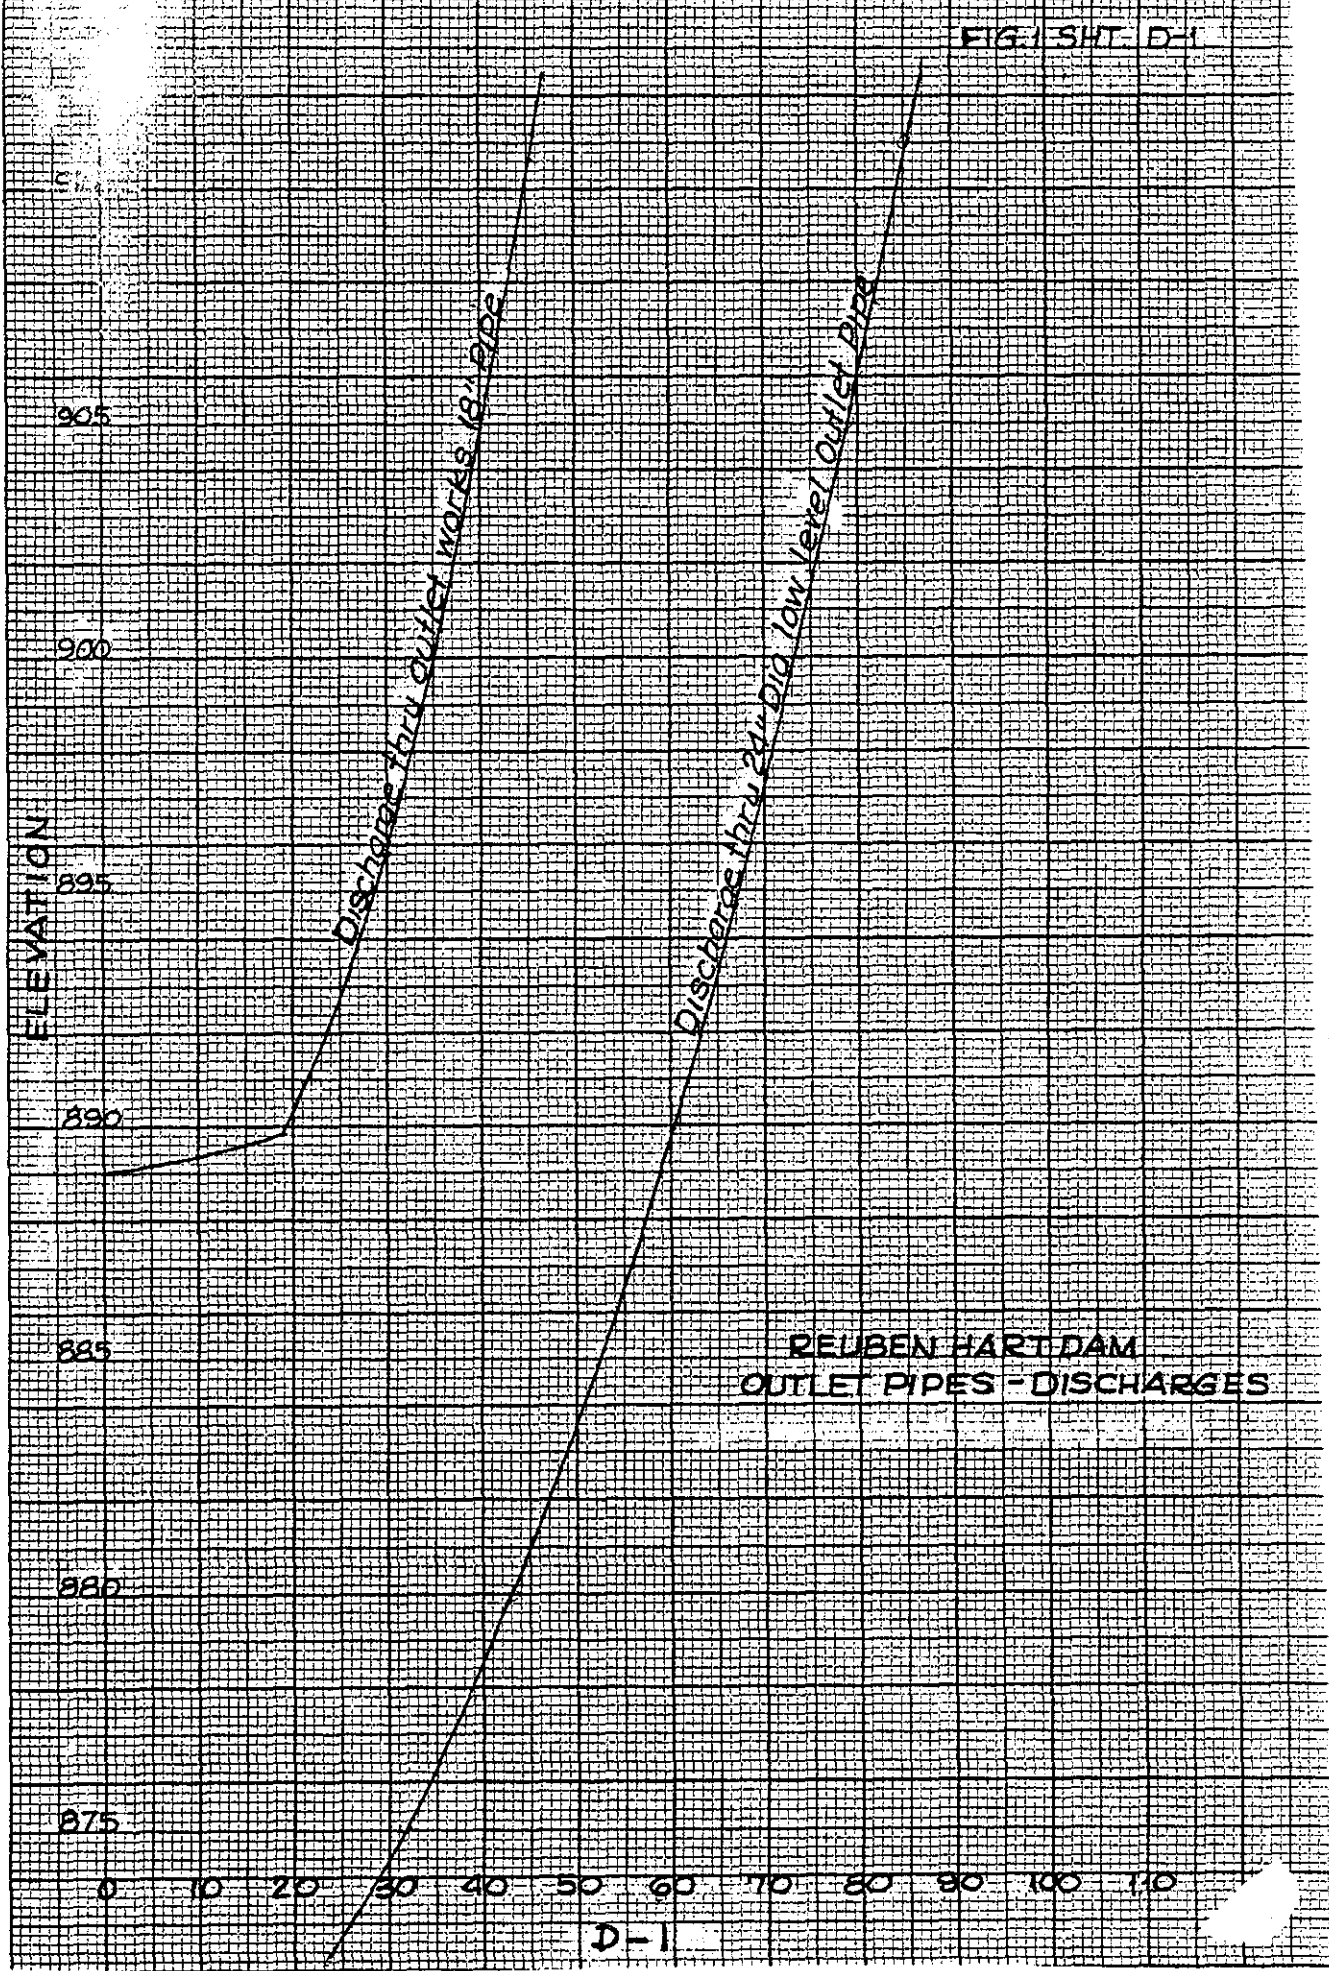
D-1

level, elevation 911. For more rapid reservoir evacuation, a low level outlet pipe which served for stream diversion during construction could also be opened, to release up to about 85 cfs at normal reservoir level. The low level pipe is said not to have been opened since construction was completed. Capacity curves are shown on Figure 1, Appendix D, Sheet D-1.

REUBEN HART DAM
OUTLET PIPES - DISCHARGES

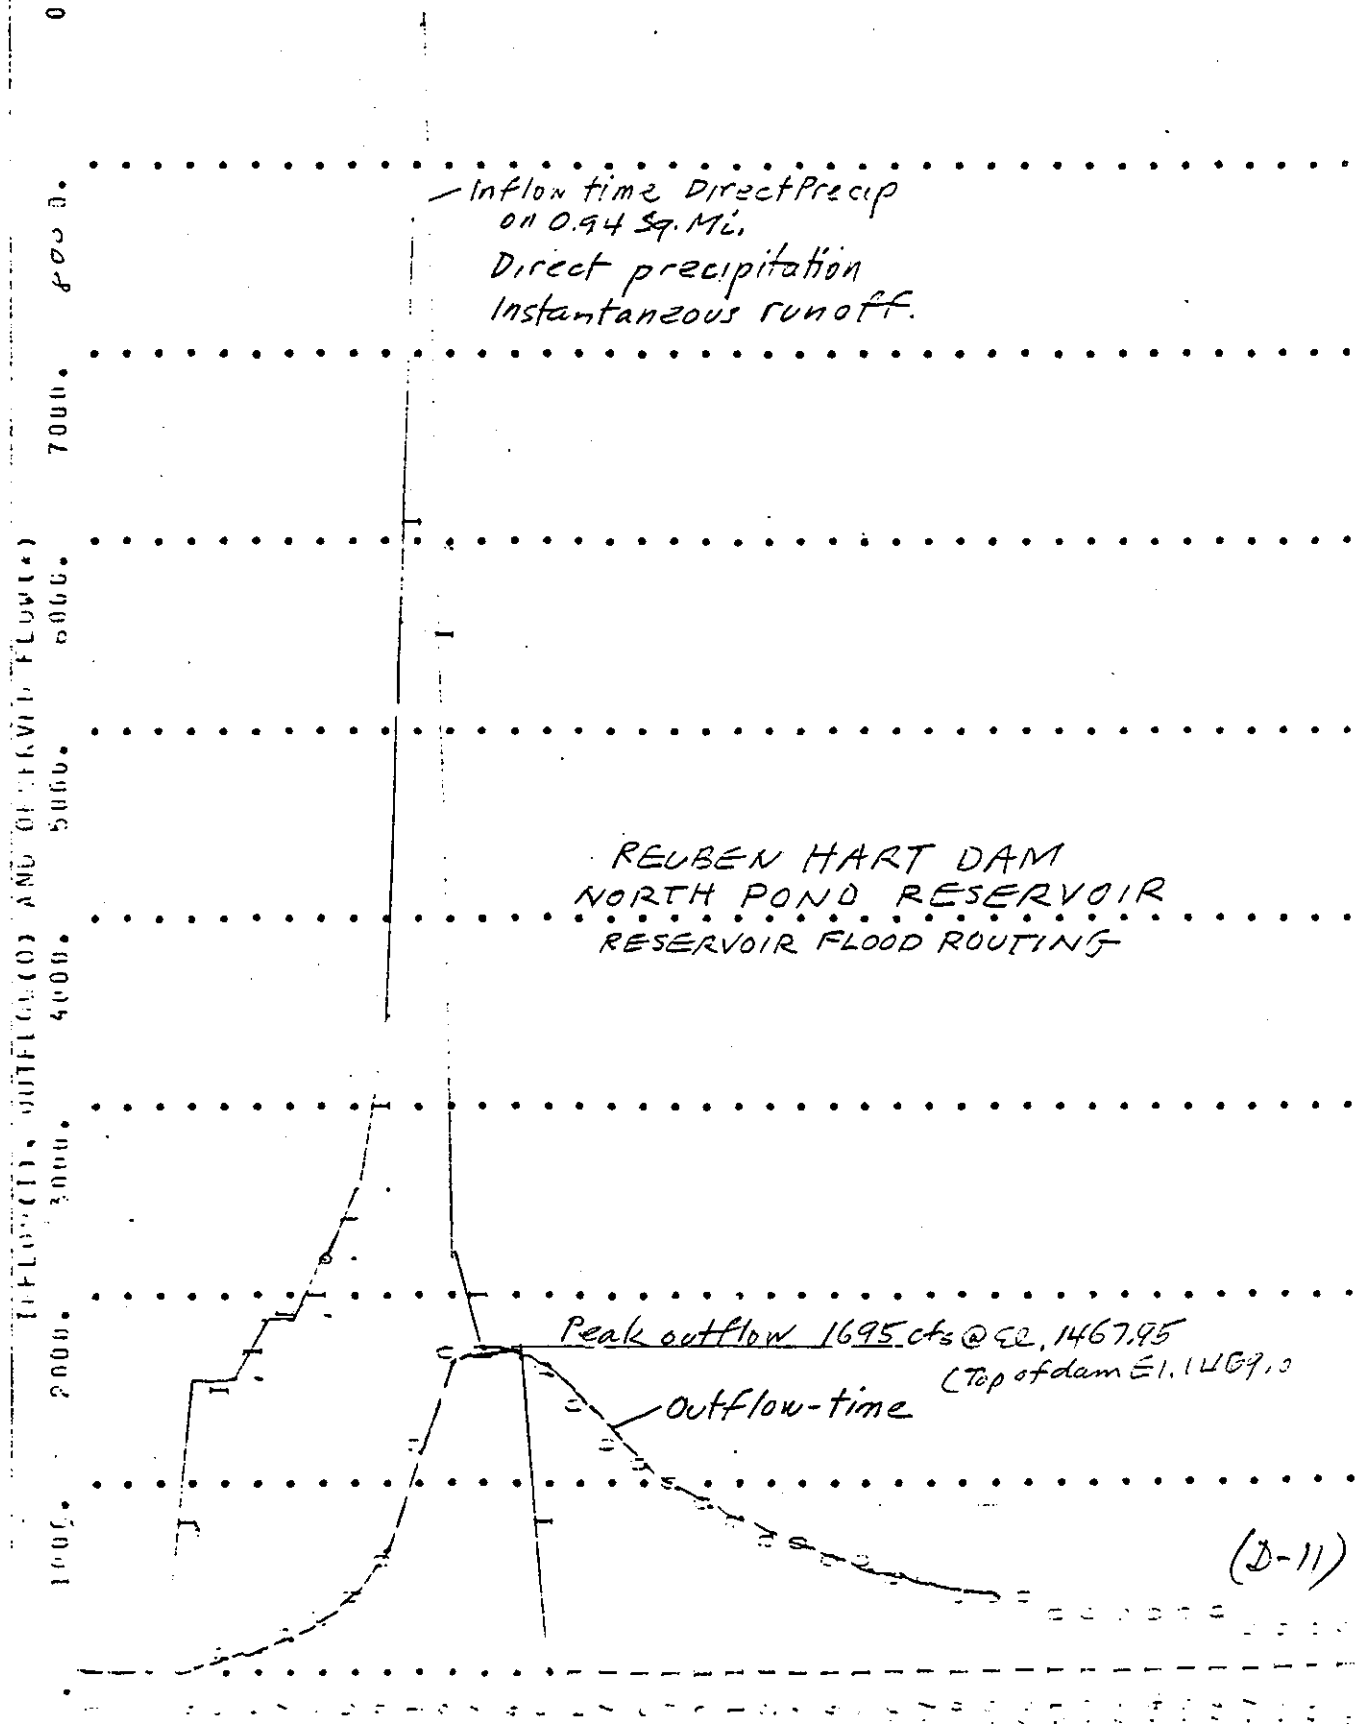
FIGURE 4
Sheet D-11

Routing the PMP direct runoff from the sub-drainage area above North Pond Dam through the North Pond Reservoir and spillway results in a peak outflow of 1,695 cfs, with surcharge storage rising to about 1 ft. below the top of that dam (see computer printout graph, Figure 4, Sheet D-11 in Appendix D). The hydrograph for the lower sub-basin indicates a peak flow of 8,048 cfs occurring at the 6th hour of the flood event. This corresponds to a value of about 1,950 cfs per sq. mile.

REUBEN HART DAM
FLOOD ROUTING OF PMF THRU
RESERVOIR AND SPILLWAYS

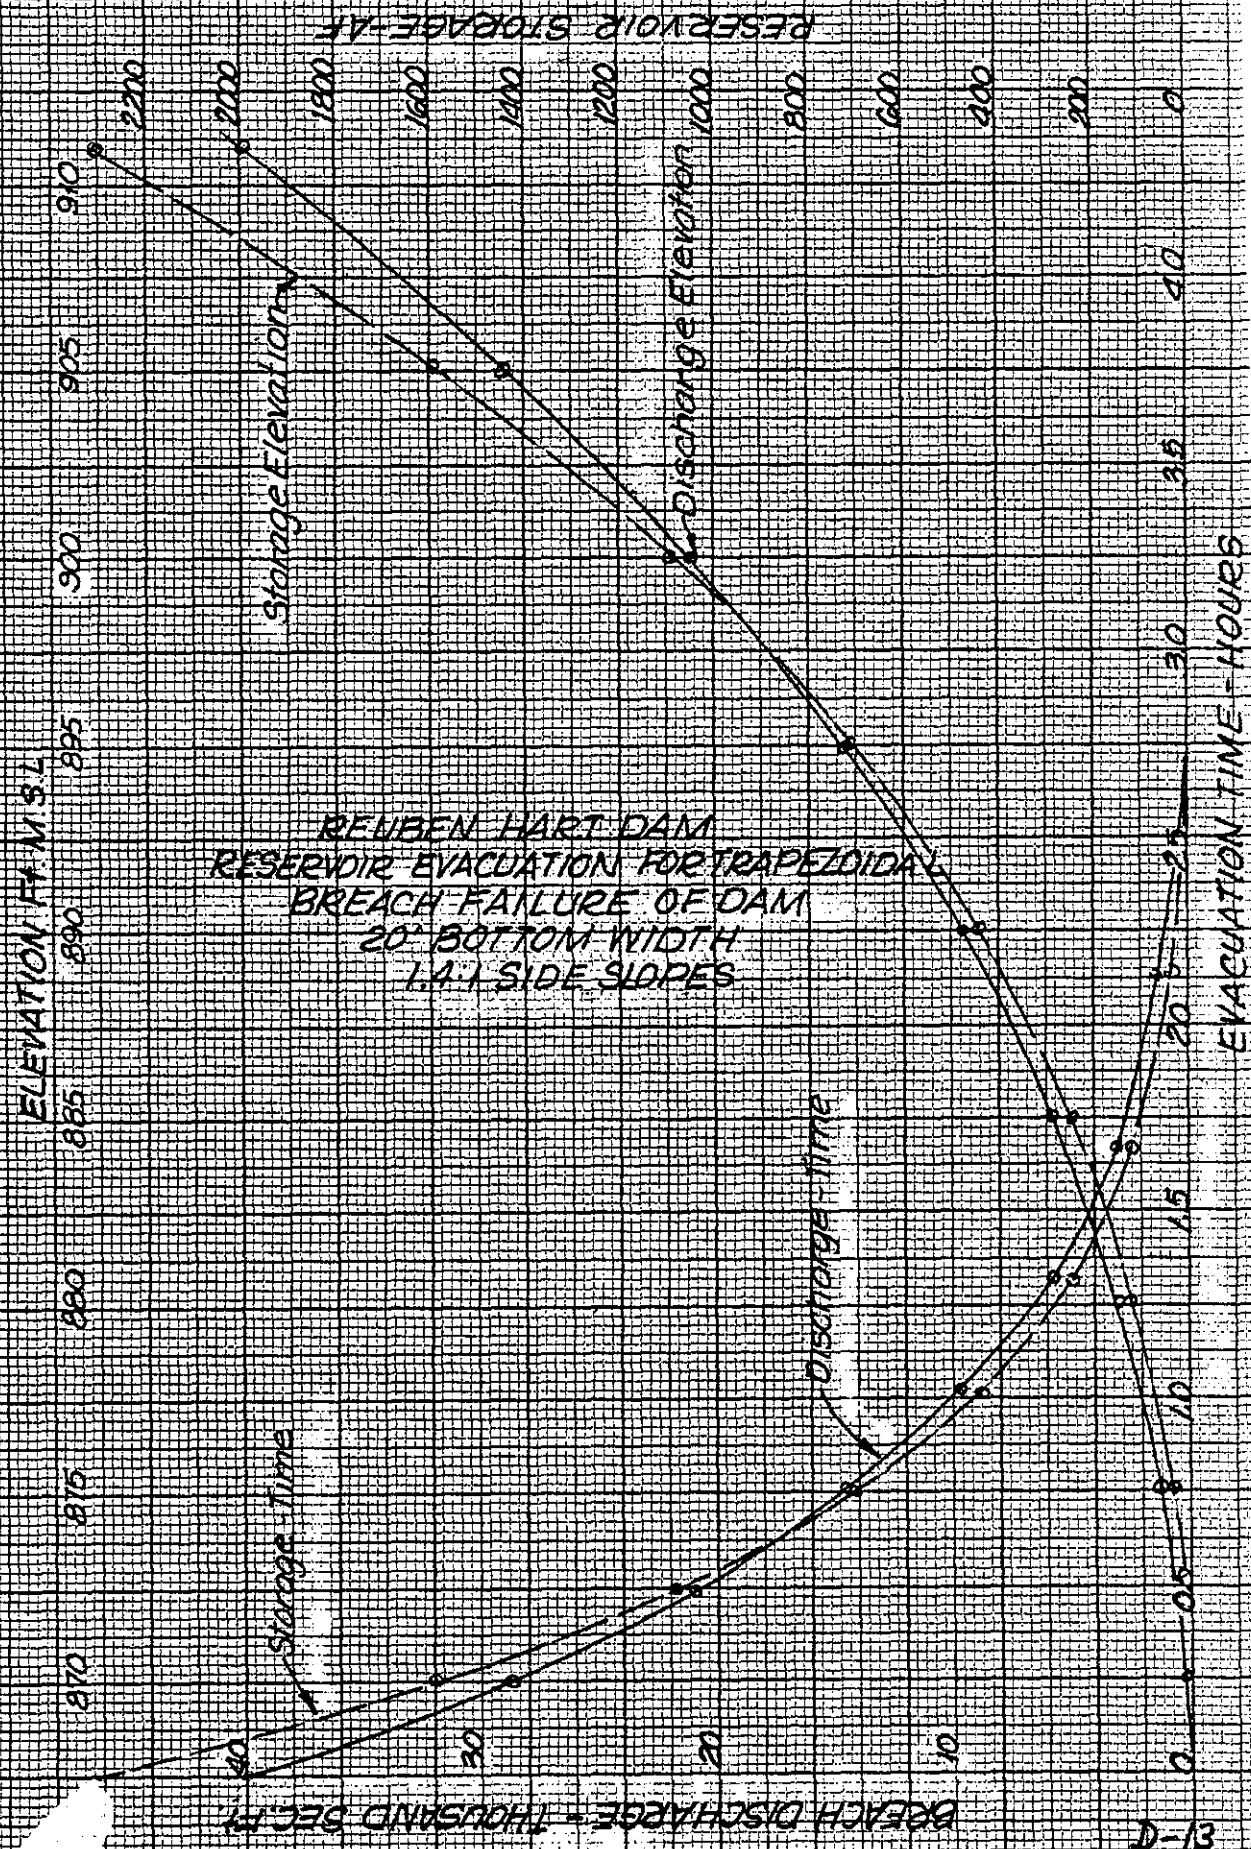
D-13

In the event of a dam failure from causes other than overtopping, it may be assumed that a breach could occur with a bottom width of 20 ft. at the level of the bottom of the dam, and with slopes at about 1.4 to 1 (angles of repose). Such a breach would suddenly release a flood wave of about 40,000 cfs downstream. This flow would diminish rapidly as the reservoir emptied. Figure 6, Sheet D-13, Appendix D shows storage and discharge versus time for such a breach emptying.

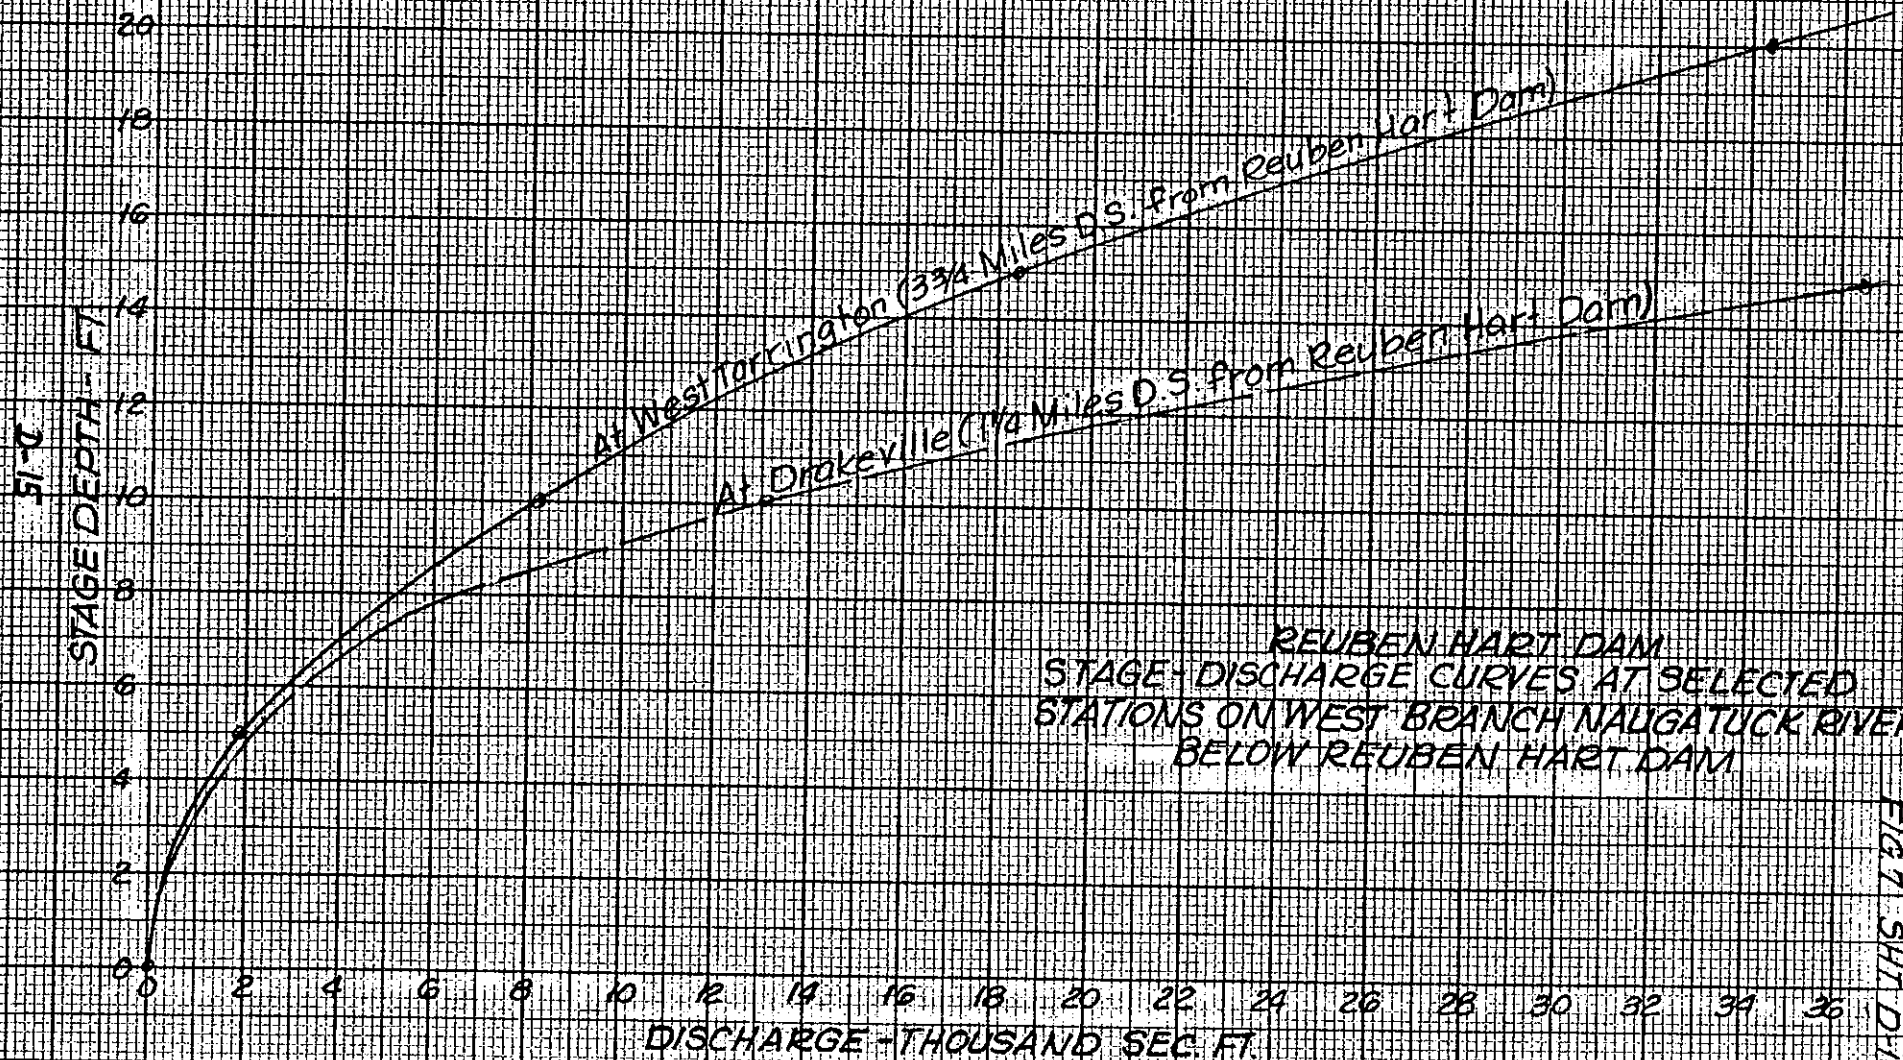
As noted in Section 1.2d and Section 3.1e, large outflows from Reuben Hart Reservoir owing to near maximum flood inflows or to a breach in the dam would cause great damage downstream to and through the City of Torrington. Stage-discharge curves for two selected points on the West Branch of the Naugatuck River below Reuben Hart Dam were computed to indicate the flow depths in the event of large outflows from the Reuben Hart and Hall Meadow Brook Reservoirs, or from a breach in Reuben Hart Dam. These curves are shown on Figure 7, Sheet D-15, Appendix D. For a 35,000 cfs outflow the stage at Drakeville, about $1\frac{1}{2}$ miles below Reuben Hart Dam, would be about 15 feet. For the same outflow the stage at West Torrington, about $3\frac{3}{4}$ miles downstream, would be about 20 feet. Delineated on the USGS quadrangle sheet (Figure 8, Sheet D-17, Appendix D) is the approximate extent of the river valley which will be inundated. It can be seen that many homes and commercial establishments near Drakeville, Wrightville and West Torrington would be inundated at this river stage.

STAGE DISCHARGE CURVE

AT DRAKEVILLE - 1 1/4 mile D.S from Reuben Hart Dam.
